Product Bulletin # TDS-246 Rev 1

Top Drive Guide Runner Wear Inspection

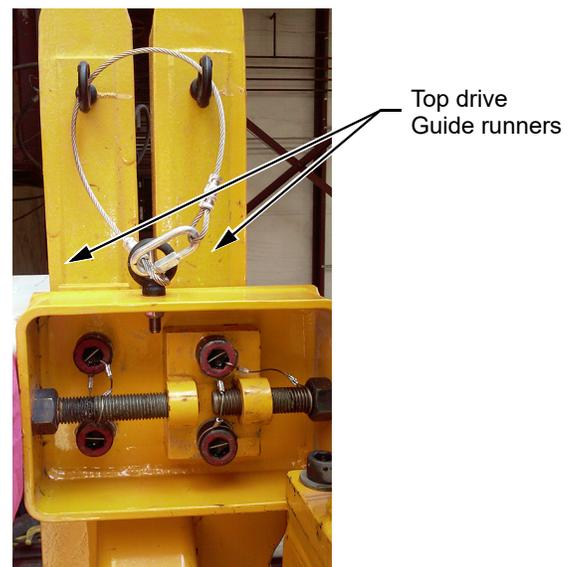
Figure 1: Top drive guide runners

Top Drive guide runners will wear over time. Periodic adjustment is required to maintain top drive alignment over well center.

1. Inspect the top drive guide runners and hardware components including, but not limited to the following to ensure the components are not missing, damaged, loose, or broken:
 - Fastening components (i.e., bolts, nuts, washers, and lockwashers)
 - Eyebolts
 - Securement components (i.e., safety wire, ferrules)
 - Shims
